**National Highway
Traffic Safety
Administration**

Case Vehicle (A): 1999 GMC
 Type: Suburban SLT 4 x 4, 4-door SUV
 Driver: 36-year-old female
 CDC: 03-RFEW-4

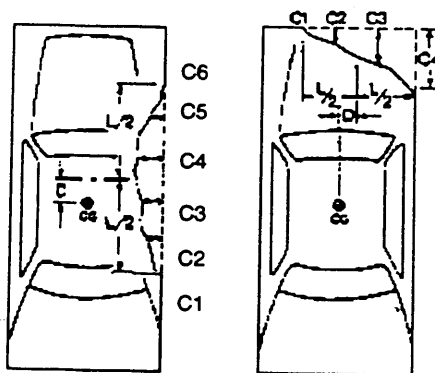
Specific Impact No.	Location of Direct Damage	Location of Field L
1	begin 50 cm rear of Rt. H. BL	223 cm rear of Rt. H. BL
		Begin Rt. H. BL

Specific Impact Number	Plane of Impact C-Measur.	Direct Damage		Field L	C_1	C_2	C_3	C_4	C_5	C_6	$\pm D$
		Length (DDL)	Max Crush								
1	4	56	95	223	0	8	31	95	68	31	+135
	Free space				-1	-1	-1	0	0	6	
	stand adjustment		-22		-22	-22	-22	-22	-22	-22	
1	4	056	073	223	000	000	008	073	046	003	+135
13	14	15 16 17	18 19 20	21 22 23	24 25 26	27 28 29	30 31 32	33 34 35	36 37 38	39 40 41	42 43 44 45
2

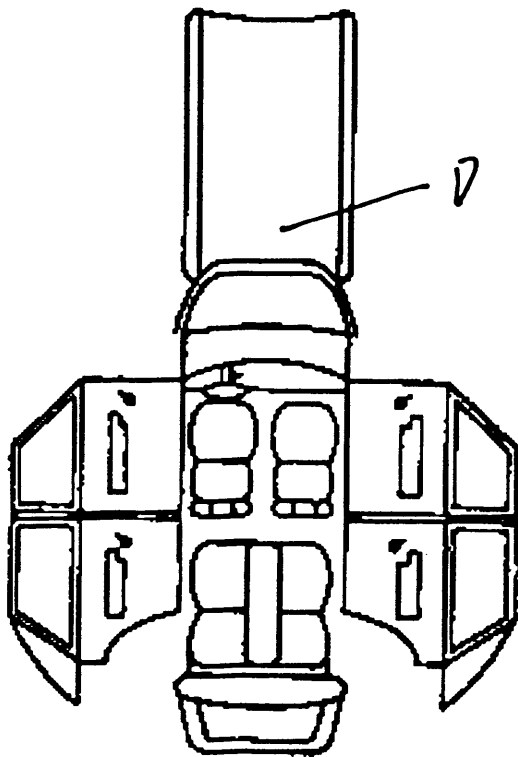
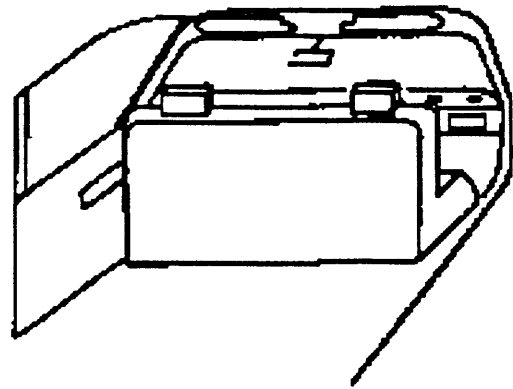
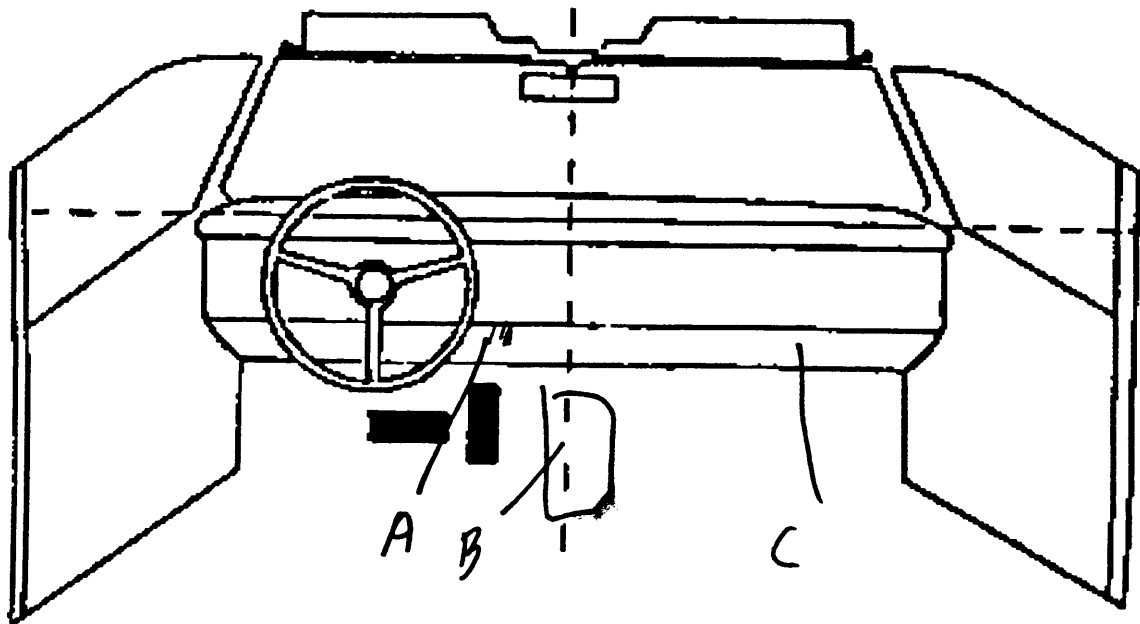
VEHICLE OCCUPANT CONTACT DIAGRAM

Contact	Interior Component Contacted	Occupant No. if Known	Body Region if Known	Supporting Physical Evidence	Confidence Level of Contact Point
A	KNEE BOLSTER	DA	Rt. Leg	Scuff	1
B	CENTER CONSOLE	DA	Legs OR Buttocks	Scuff	1
C	GLOVE BOX	RF	Legs	Scuff	2
D	Roof	DA	Head	Scuff	1
E					
F					
G					
H					
I					
J

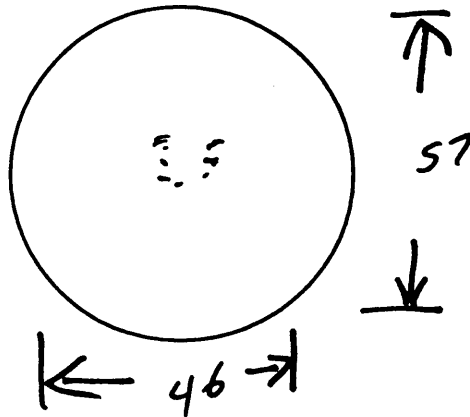
NOTE AND DESCRIBE ANY AIRBAG CONTACT OR
DAMAGE ON DIAGRAM BELOW:

2 JENTS @
11 + 1

LF 11 T
7 W

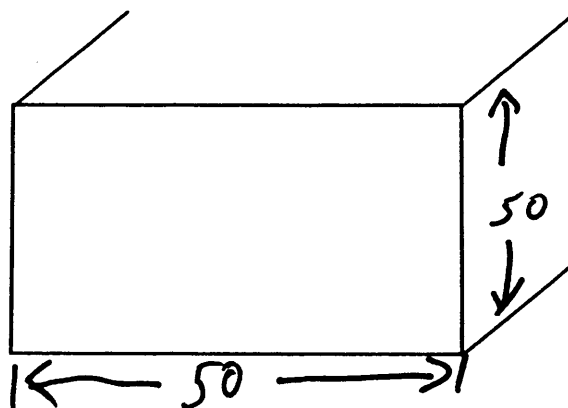
NOTE AND DESCRIBE ANY AIRBAG CONTACT OR
DAMAGE ON DIAGRAM BELOW:

2 JENTS @
3 + 9 on
SIDE

LF 32 W
6 T

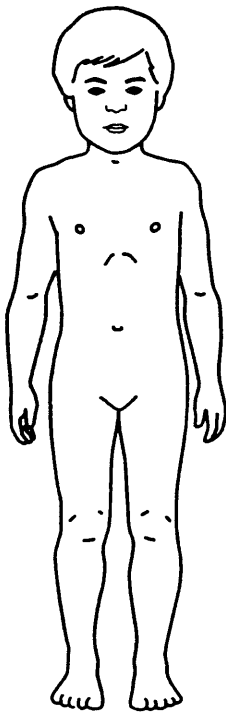
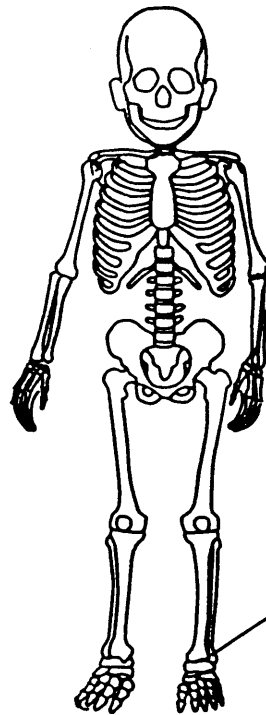
Hairline fracture,
distal
left fibula
(2)

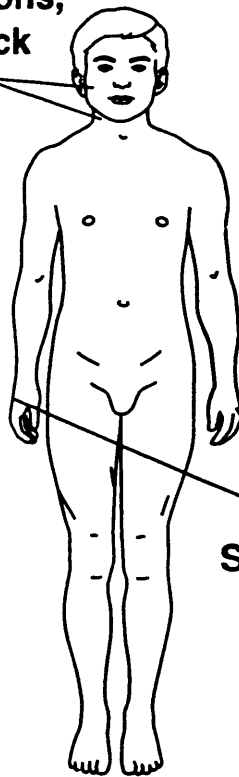
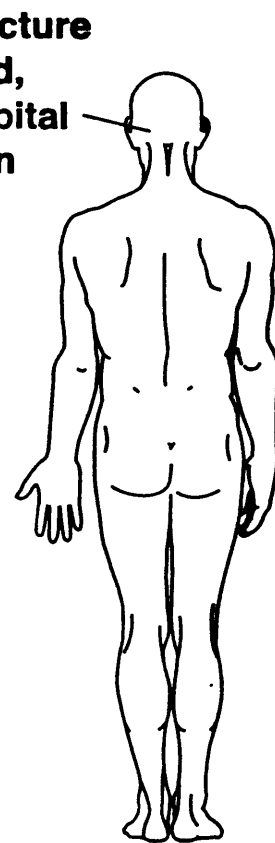
Small lacerations,
face and neck
(1)

Small lacerations,
both hands
(1)

Small puncture
wound,
left occipital
region
(1)
